# National Transportation Safety Board

## P-51D The Galloping Ghost

September 16, 2011

Reno, NV

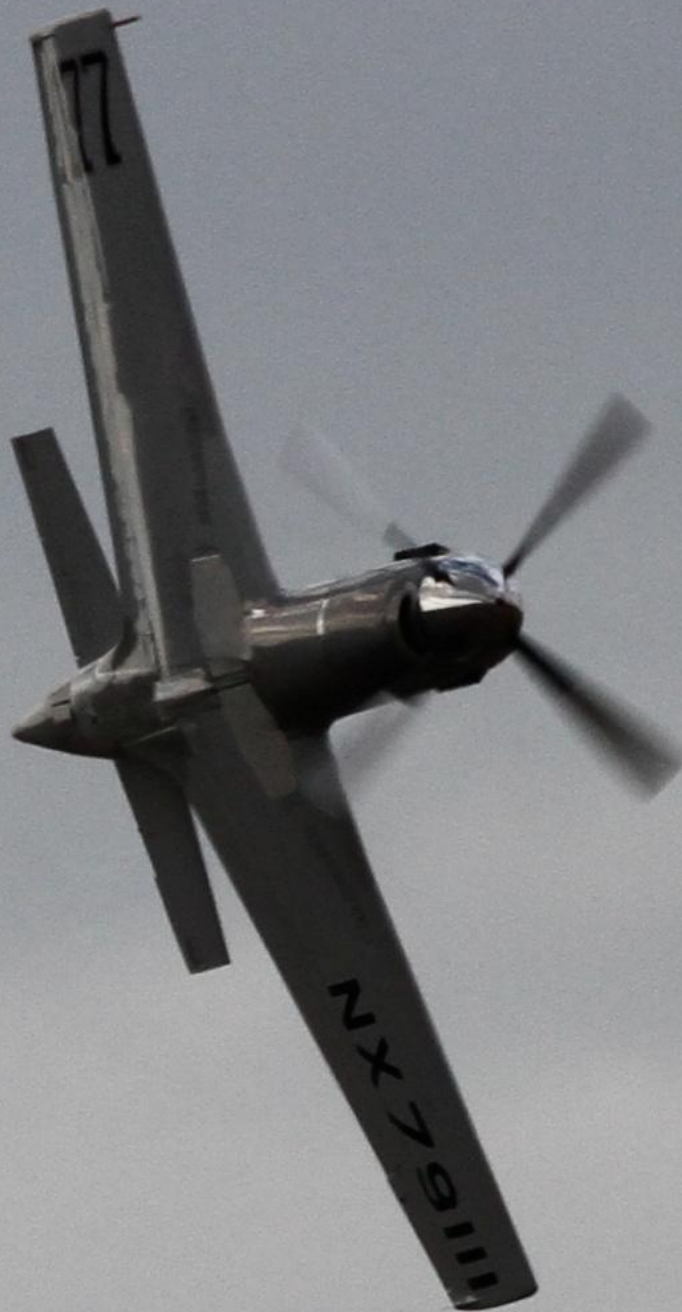
**T-0.25 seconds**

**Right Elevator  
Trim Tab**

**Left Elevator  
Trim Tab**

**Left Aileron**

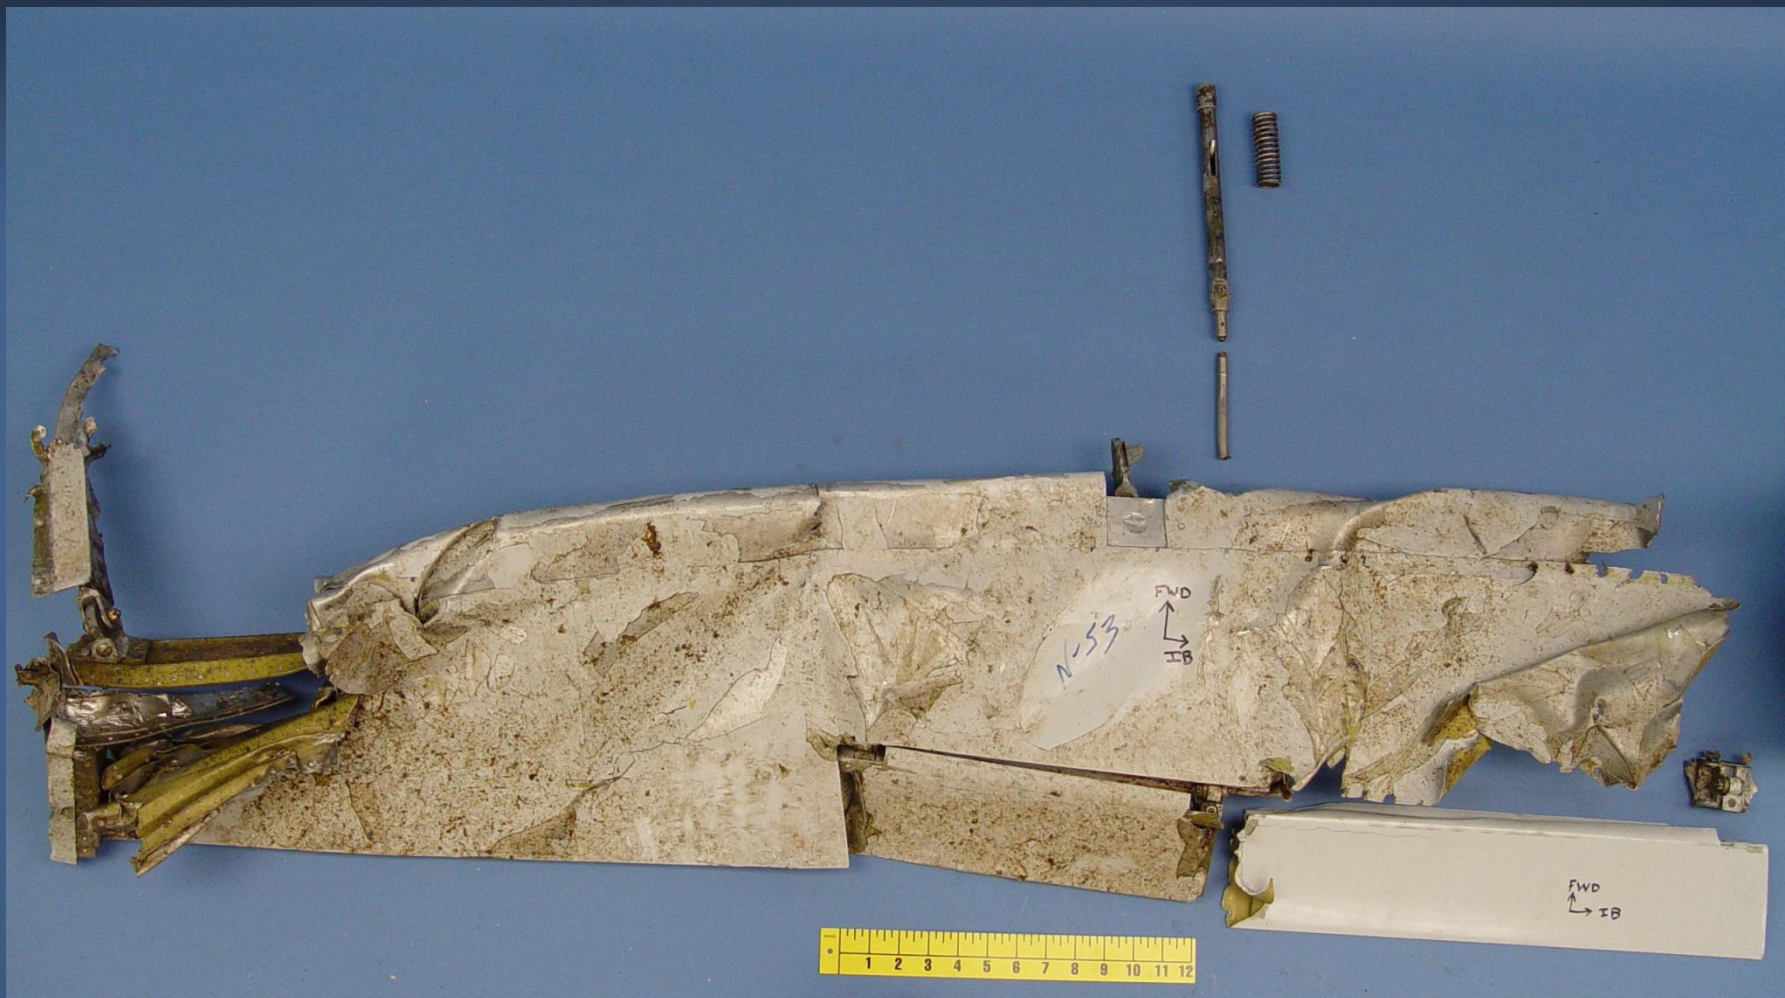
# Left Elevator

- Loose screws reduced stiffness
- High race speeds
- Flutter of left trim tab
- Failure of left link assembly
- Uncommanded pitch up and high G
- Flutter of right trim tab
- Failure of right link assembly
- Separation of inboard left tab

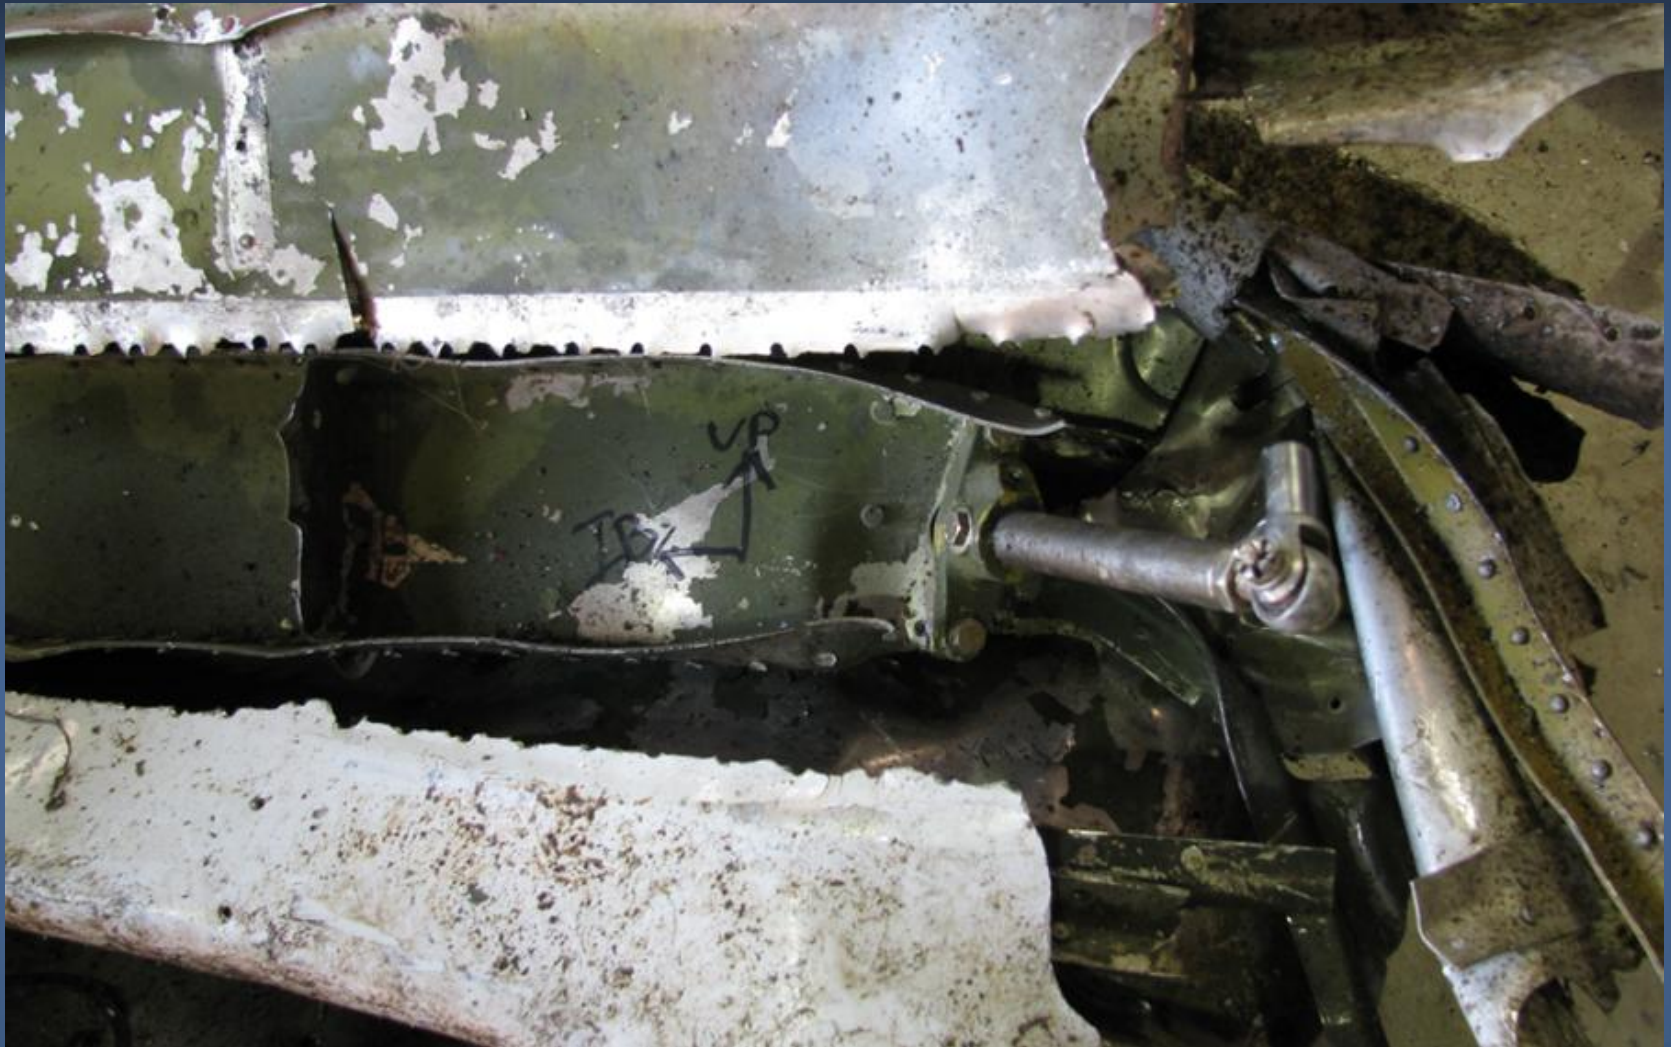
# Fixed Right Trim Tab

- Reduced elevator inertia weight
- Increased elevator counterweights
- Increased rudder counterweight
- Fixed and faired right elevator trim tab
- Electrically actuated left elevator trim tab
- Filler and paint on elevator trim tabs
- Modifications increased pitch sensitivity
- Pitch trim system more susceptible to flutter

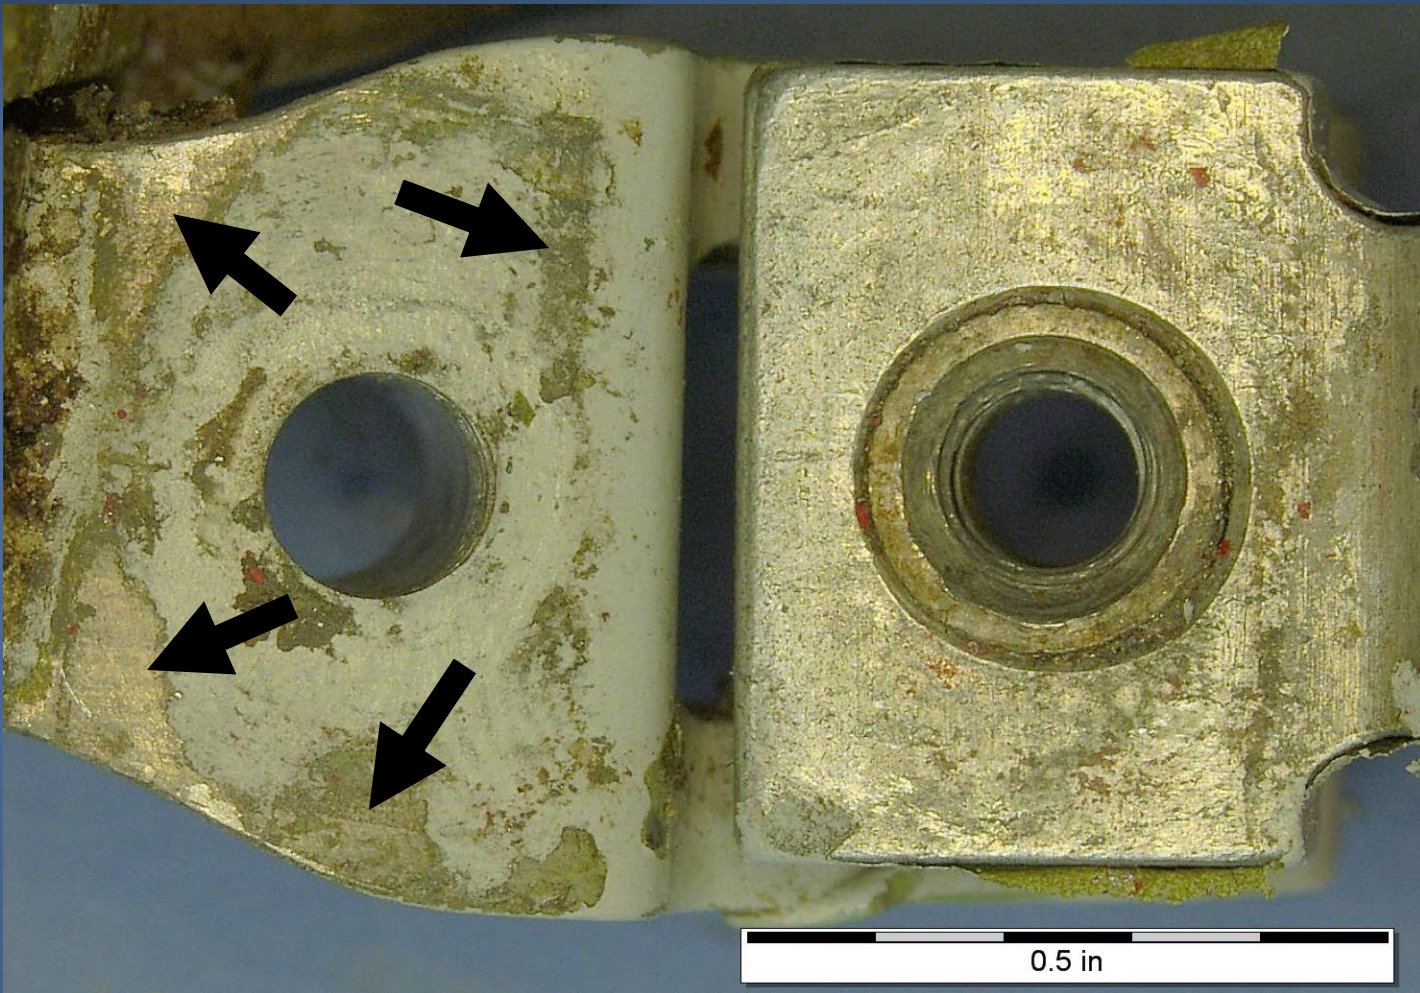
# Examination-Hinges

- Link assemblies
  - Overload failure in bending
  - Compressive buckling deformation
  - Internal elevator damage
- Screw
  - Fatigue fracture 80%
  - Overload fracture 20%
  - Corrosion on fracture

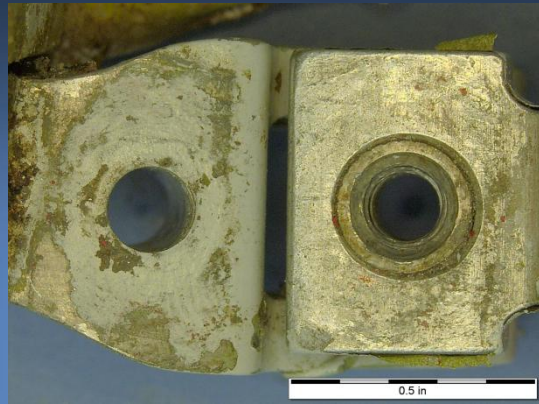
Left CTR

# Locknuts
